Investigation at the Bottom of Railway and an Embankment by Sounding Method

Key Words : Railway Embankment, Safety, New Investigation Technology, NSWS Testing Apparatus

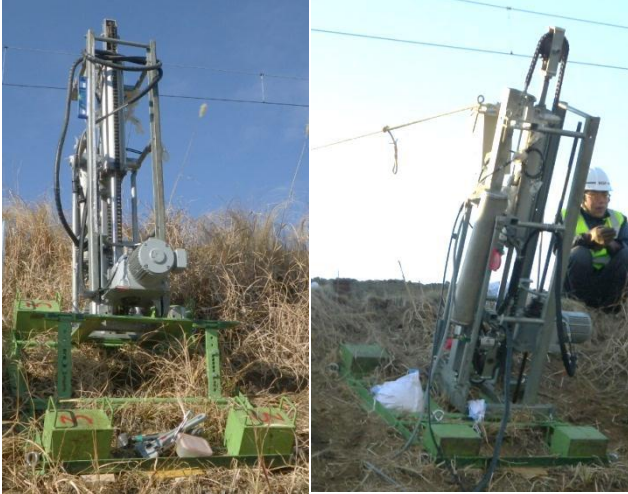
Fig.2 of NSWS Testing Machine, Left)Vertical Right)Diagonal

Fig. 2 shows a mounting scene of the main device. Also, a concrete drill bit (φ22mm) is adopted for a tip of a rod instead of a screw point.

The screw point has limitations when penetrating ground with many gravels mixed. With the drill bit increases a penetration capability, and straight advancing ability of rods. And those usually considered impenetrable soil layers such as a gravel layer can be drilled and measured continuously by utilizing

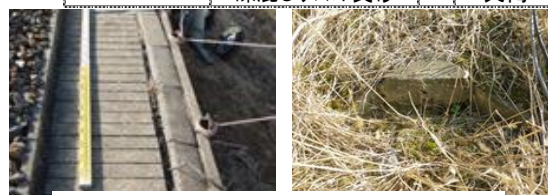
Fig.10 Embankment B, a Gap Deformation, Thinning Deformation

As indicated in Fig. 10, at embankment B following deformations were identified: a gap at the top of the slope, and a subsidence at a top of the formwork.

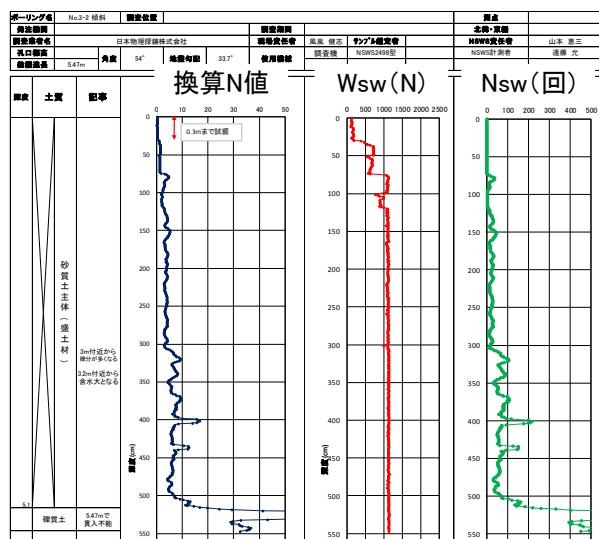
Fig. 13 Embankment B, Test Result Diagram at location ②, Diagonal Direction

On the other hand, as indicated in Fig. 13 at ② diagonal hole a loading amount is constant, 1000N, from 1.2m, and from GL-3m a converted N-value becomes about eight that indicates a different ground situation from location ①. Because of these analysis, one could conclude that the saturated weak stratum does not extend toward the center of the embankment and planned an additional vertical survey.

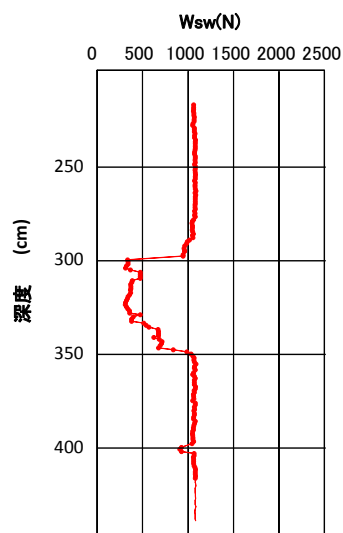
Fig. 14 Wsw around GL-3m at ① Vertical Hole

Fig. 14 is the result of loading amount[Wsw] at GL-3m and nearby at location ①, a vertical penetration, and an example of a self-scuttling of NSWS testing machine.

1. Right before GL-3m, penetration velocity increased drastically, exceeding a setup value; At this moment, penetration and rotation stopped automatically.

2. Subsequently, NSWS resets the loading to 0N and starts over the measurement

3. It continues to sink by itself until 3.3m with 300 ~ 400N.

4. From 3.3m to 3.5m it gradually increases the loading until it reaches 1000N.

5. At 3.5 NSWS starts rotation.
